# MARINE WORKS

*A PRACTICAL TREATISE FOR  
MARITIME ENGINEERS, LANDOWNERS  
AND PUBLIC AUTHORITIES*

BY  
ERNEST LATHAM

1922

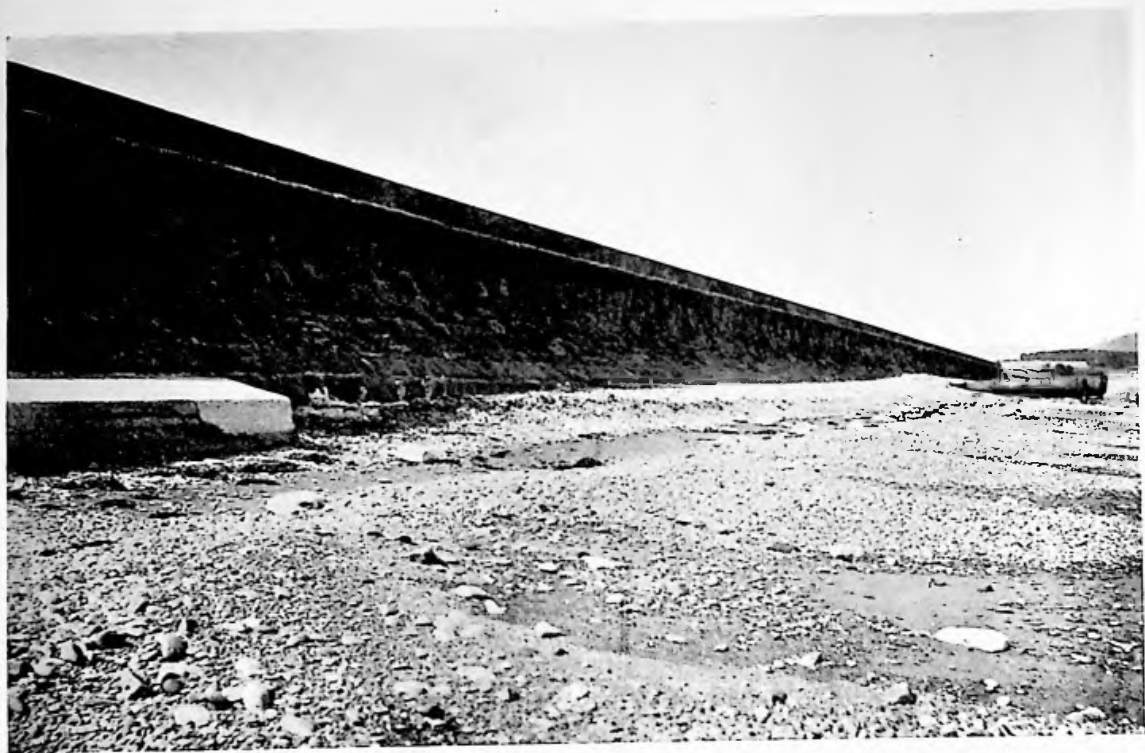
Example of Erosion at Foot of Masonry Sea-Wall, 1921.

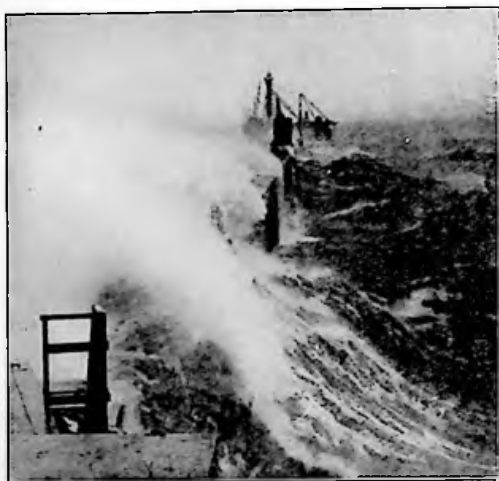
FIG. 1.—Travelling Wave meeting an Obstruction.

The worst sea, from the engineer's point of view, is the breaking sea where the final onslaught of the wave is exactly on the alignment of any defensive works, sea-wall, mole, quay, etc.

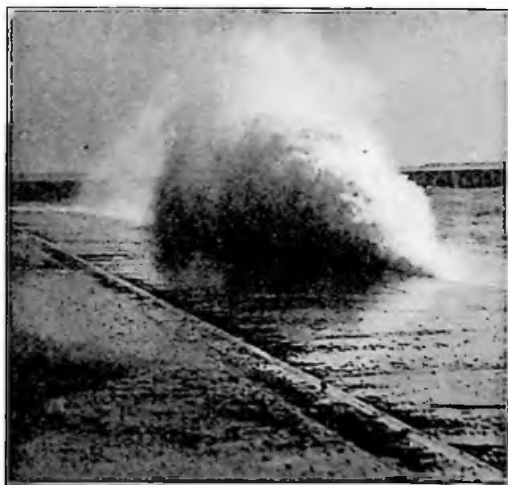
FIG. 2.—Vertical Deflection of Oncoming Wave.

of artificial structures, an oncoming wave is thrown vertically upwards (see Fig. 2), a very intense downward pressure is caused by the subsequent descent of the water which, in exposed situations, may safely be taken as reaching 700 lbs. per sq. ft. This is a very important action, and the late Mr W. T. Douglass expressed the opinion in 1911 that probably 50 per cent. of sea-wall failures were due to this downward action destroying the surfacing behind the sea-wall proper.

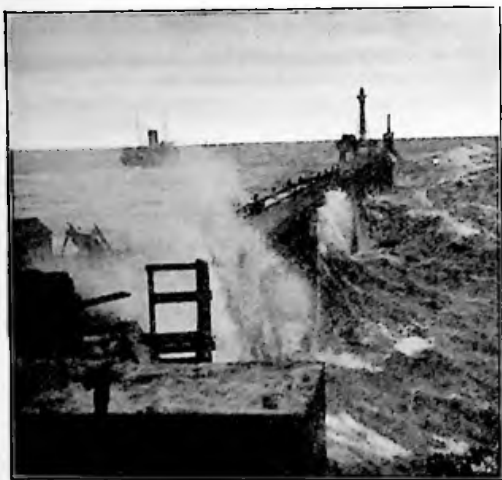
FIG. 4.—Oscillatory Wave meeting Obstruction.

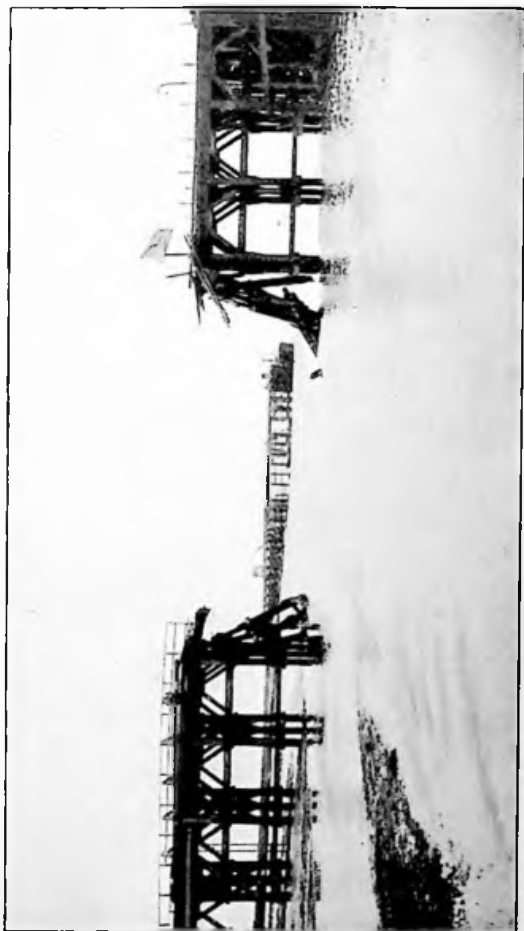
FIG. 13.—Damage to Timber Jetty at Purfleet.

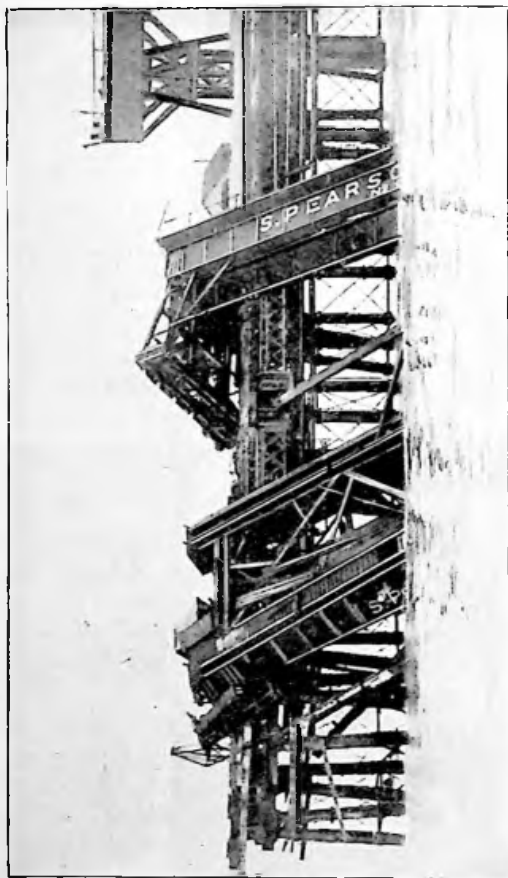
FIG. 18.—Wreckage of Plant at South Breakwater, Dover Harbour, 1906.

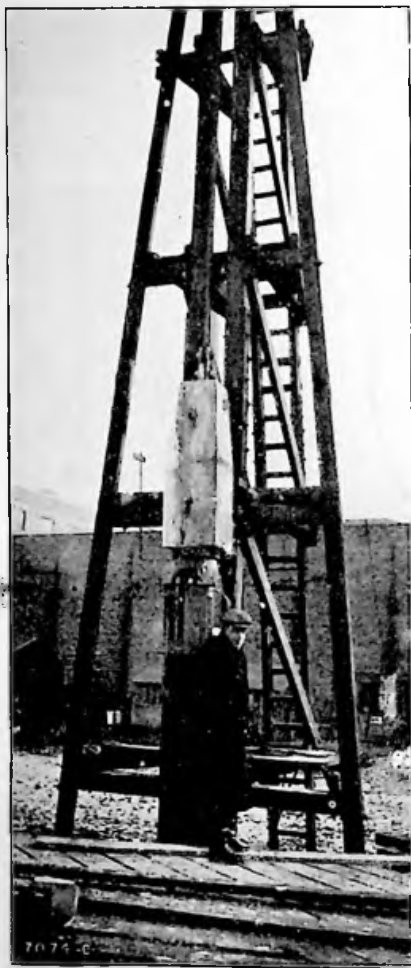
FIG. 36.—Pile-Driving Gauge under Test.

water to be in exact balance before the delivery of the blow from the pile-driving hammer. This gauge is illustrated in

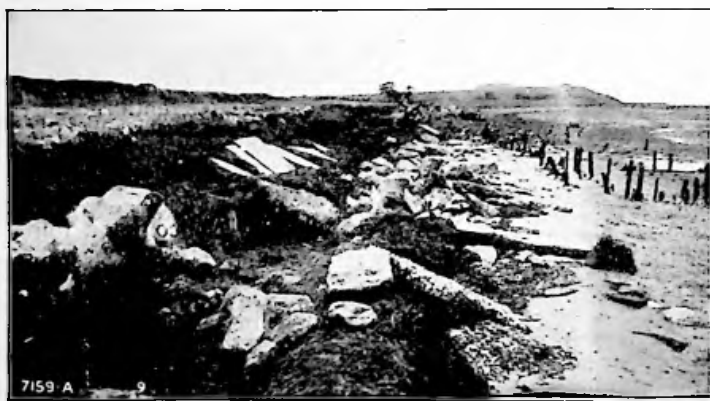
FIG. 39.—St Osyth Sea Defences.

Another example of this class occurred at St Osyth, Essex, in 1920. In this case there were some 250 acres of low-lying land threatened with inundation. The two photographs reproduced illustrate the condition of this frontage: 350 lineal ft. were similar to the photograph, Fig. 39, and 1,400 lineal ft. like the photograph, Fig. 40, at places even worse owing to the complete demolition of the timber facing by decay preceding wave action. Figs. 41 and 42 give the respective typical cross sections, and Figs. 43 and 44 the proposals for refacing the embankment in reinforced concrete. The site is at the estuary of the River Colne where it joins

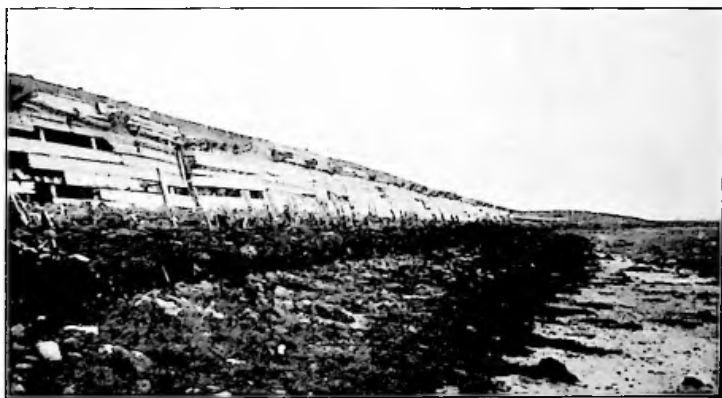
FIG. 40.—Another View, St Osyth Sea Defences.

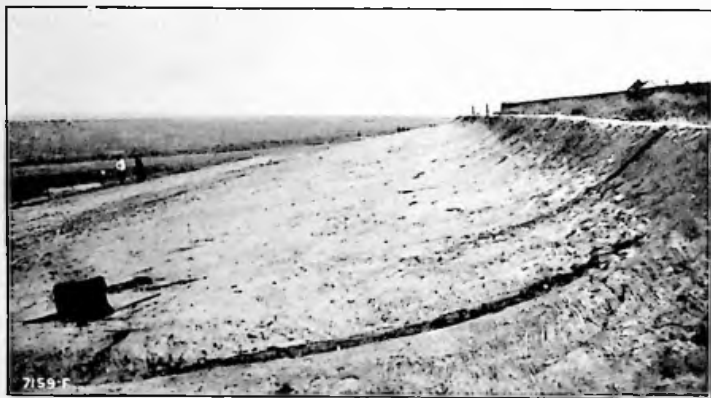
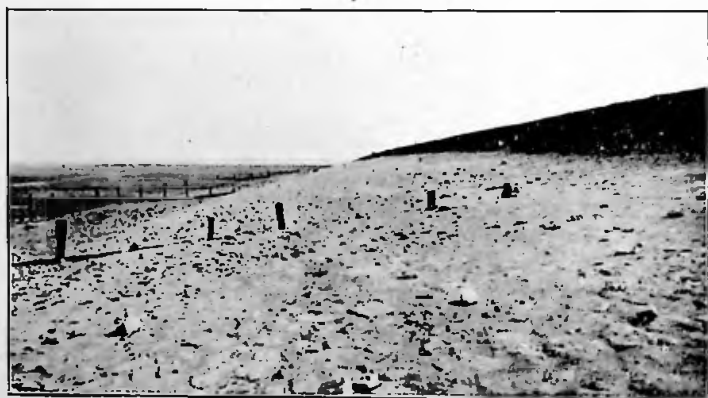
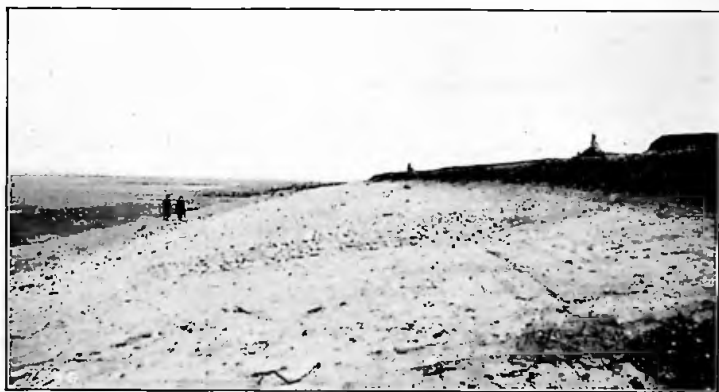
FIG. 45.—Leysdown Sea-Wall.

FIG. 46.—Leysdown Sea-Wall.

FIG. 47.—Leysdown Sea-Wall.

The profile of the wall itself is shown in Figs. 45 to 47, and it consisted of London clay pitched on the surface with stone and grouted in with sand cement.

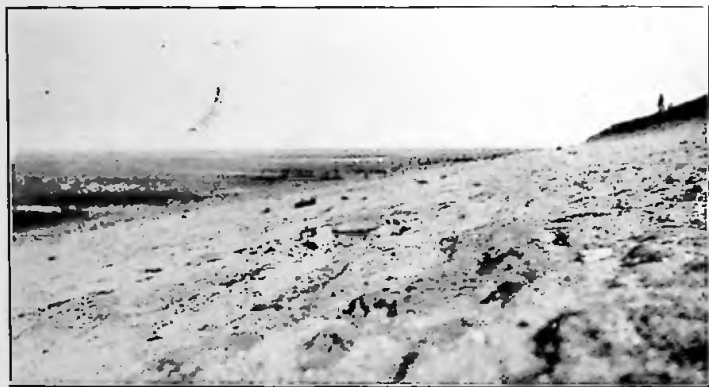
FIG. 49.—Damage to Leysdown Sea-Wall.

Fig. 49 gives a close view of the pitching which the Air Ministry maintained was in bad condition, and the prime cause

There is little doubt that this failure was directly attributable to "wave action" in the deep strata of London clay, and the recent experimental investigation made by Mr A. S. E. Ackermann B.Sc., indicates that the detonation of high explosives momentarily reduced the clay to a fluid state

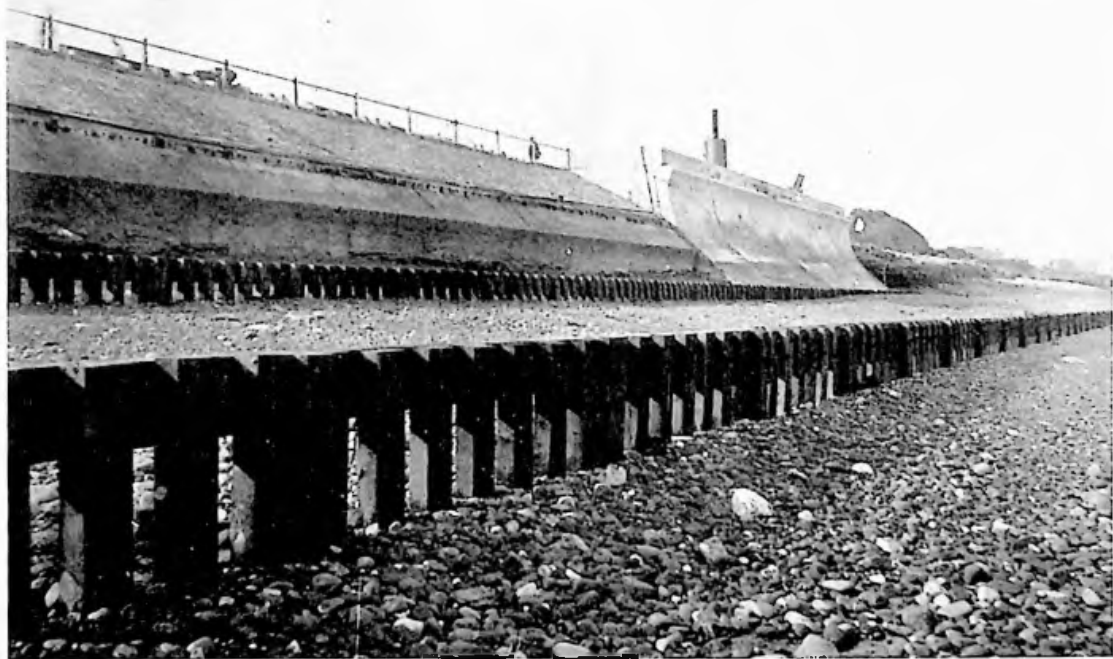
FIG. 56.—View of Stockade, Minchhead-Watchet Road, Somerset.

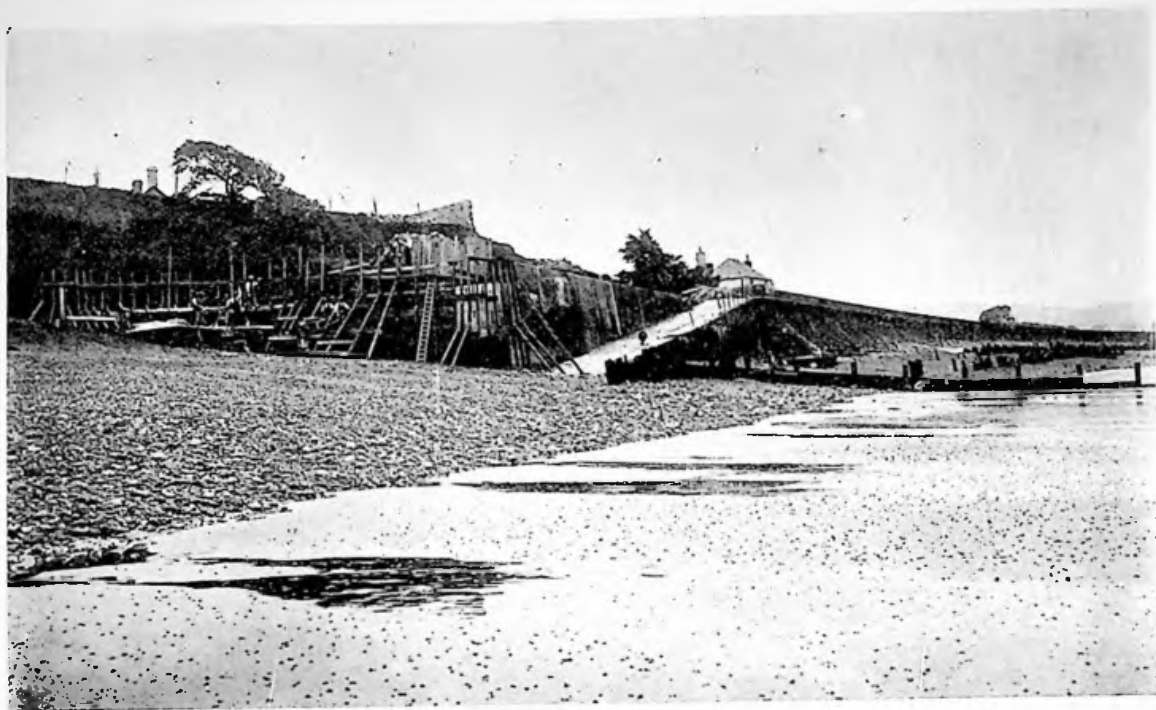
FIG. 57.—Groyne and Sea-Wall, Chapel Cleeve, Somerset.

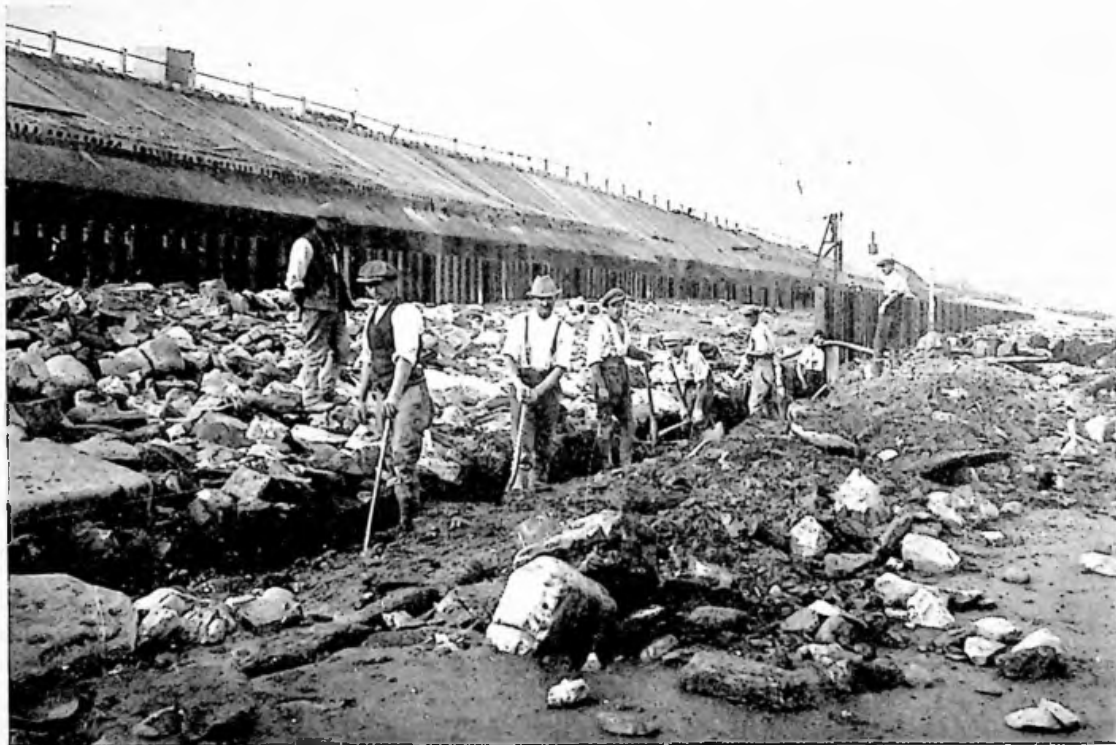
FIG. 58.—Rock Trenching, Minehead-Watchet Road.

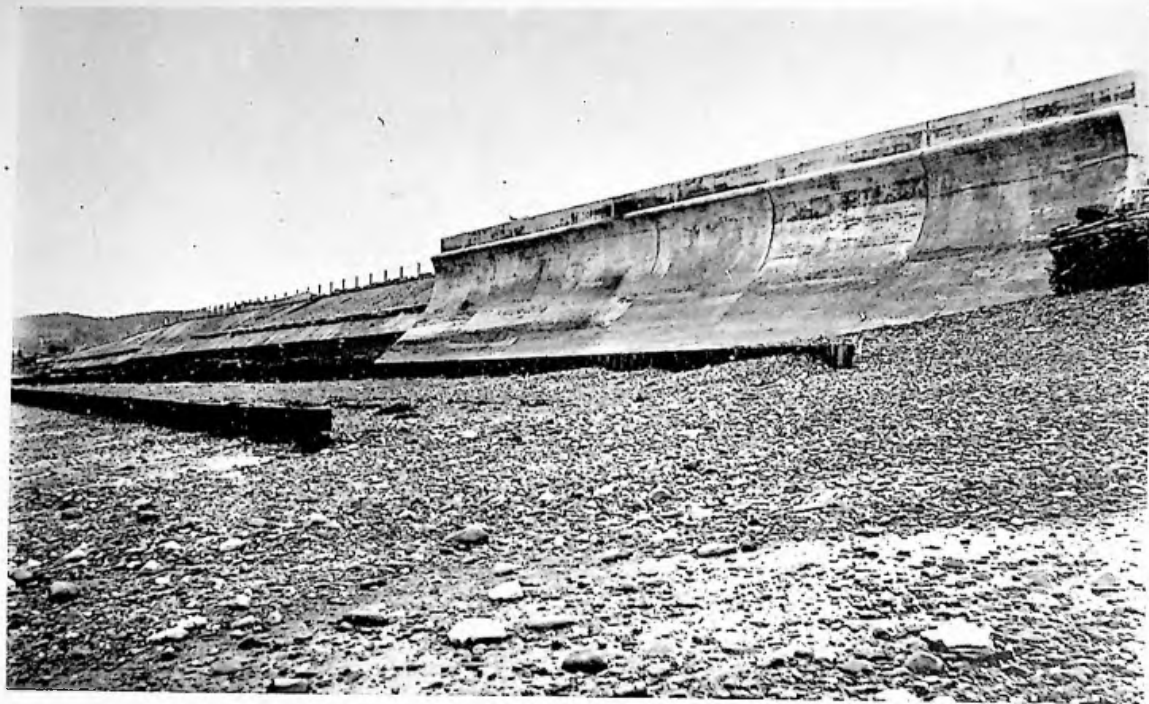
FIG. 59.—Effect of Stockades on Accretion of Shingle.

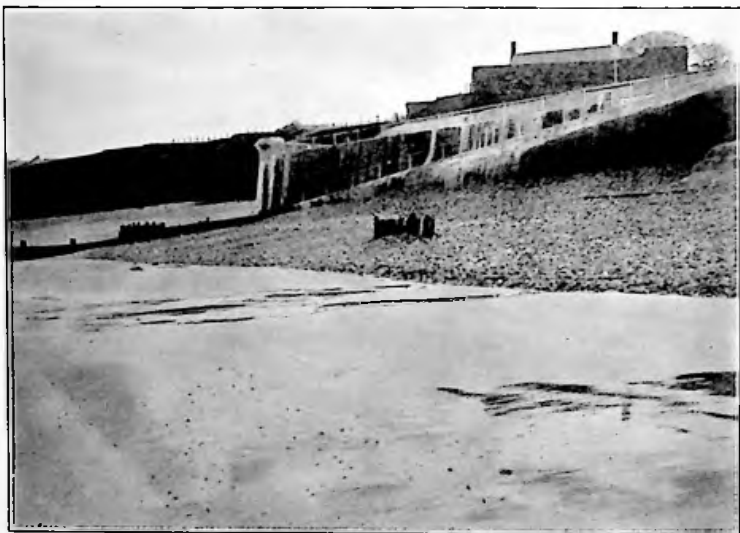
FIG. 64.—Adjustable Timber Groyne.

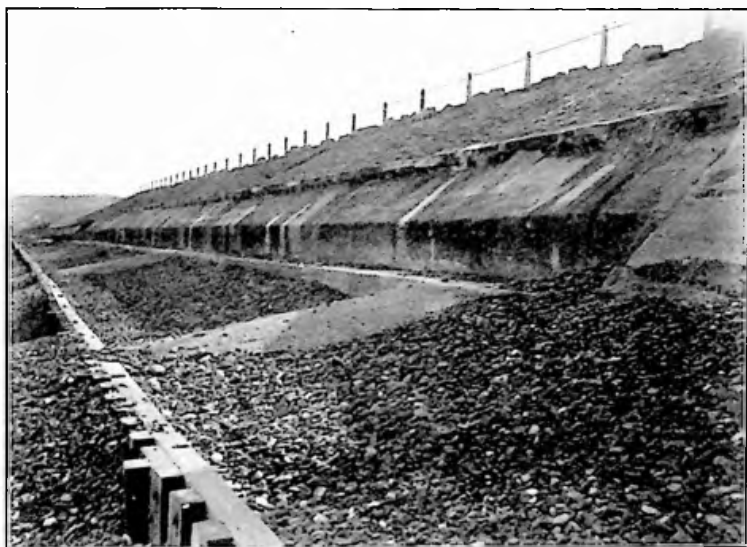
FIG. 67.—“Stub” Groynes.

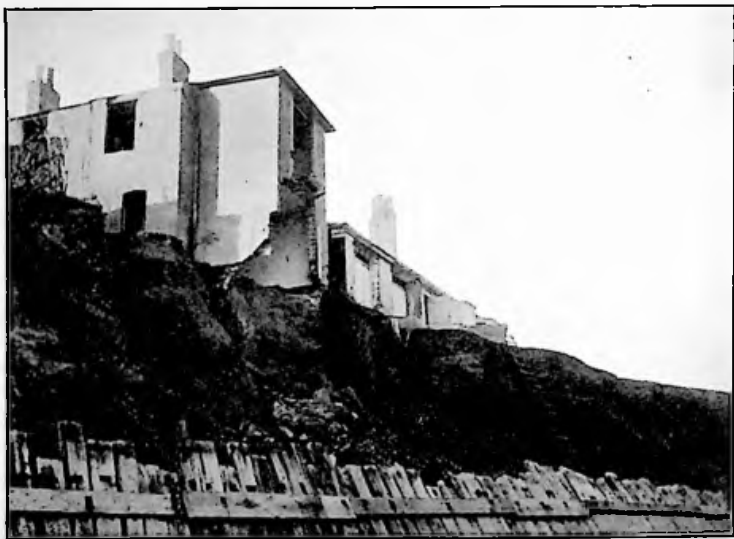
FIG. 71.—Scouring Action at Southwold, Suffolk, 1906.

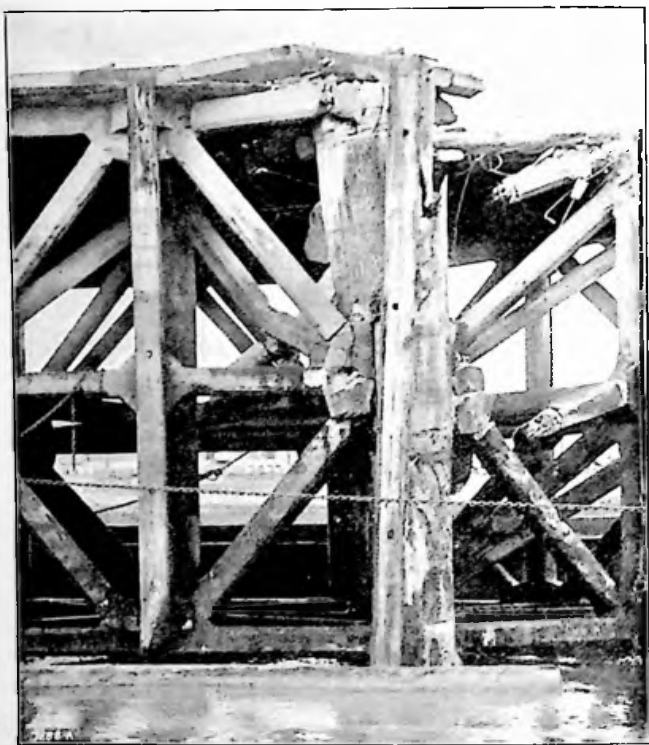
FIG. 72.—Reinforced Concrete Quay, damaged by 6,000 ton Steamer.

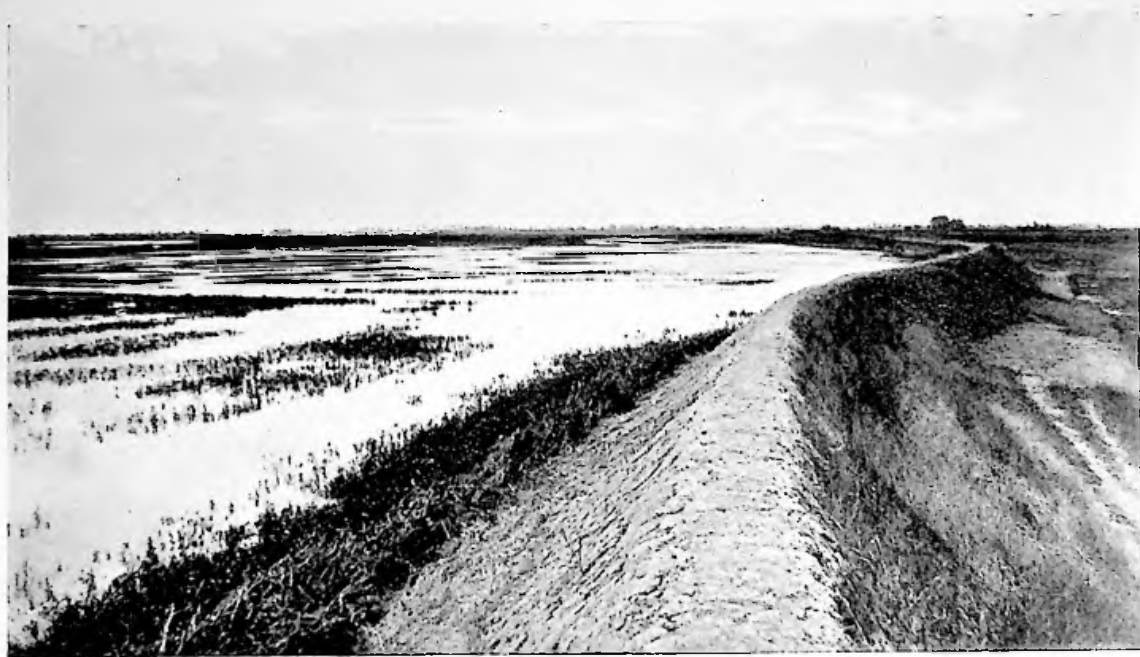
FIG. 81.—Breaches at Fingrinhoe Marshes, 1922.

This breach is only one example of many which exist on the rivers and estuaries of the East Coast, notably at Fingrinhoe Marshes (see Fig. 81), and the cost of reparation of such
